# Case Study

## 4 STAR HOTEL RADISSON BLU AMSTERDAM, THE NETHERLANDS

Project: Locatie: Design entree Afmetingen: Entree Radisson Blu Amsterdam, The Netherlands Circular Full Vision, CFV 2700 AY TALL Ø 2700 mm, height 5500mm

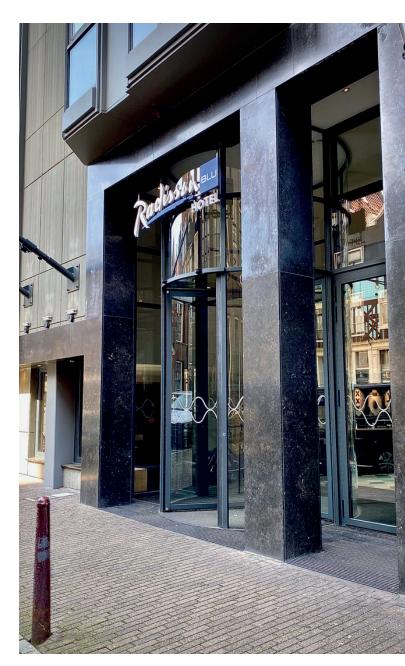
This revolving door is constructed from a welded stainless-steel construction, which is 'screwless' clad with set and rolled aluminum cladding. The rotating part is stable and is composed of a stainlesssteel shaft (mirror finished) with the door wings suspended from it.

With this revolving door, security sensors have been placed on the corner parts of the door wings that look past the door wings. If the rotating part catches up with the passer-by while turning and the passer-by enters the security field, the rotating part will stop. If the passer-by moves out of the security field, the rotating part will start up again.

There are also vertical clamp protection sensors placed at the run-in end posts. When the passer-by is trapped, the active brake immediately engages, the rotating section stops and when activated for more than 3 seconds, the rotating section turns back for 500mm. These sensors look vertically downwards and stop the rotating part if there is a risk of trapping; before the passer-by is hit.
